New York State Department of Transportation

Yellow Flag NB2358W002

BIN: 1065318

Feature Carried: 278I278IX2M23027

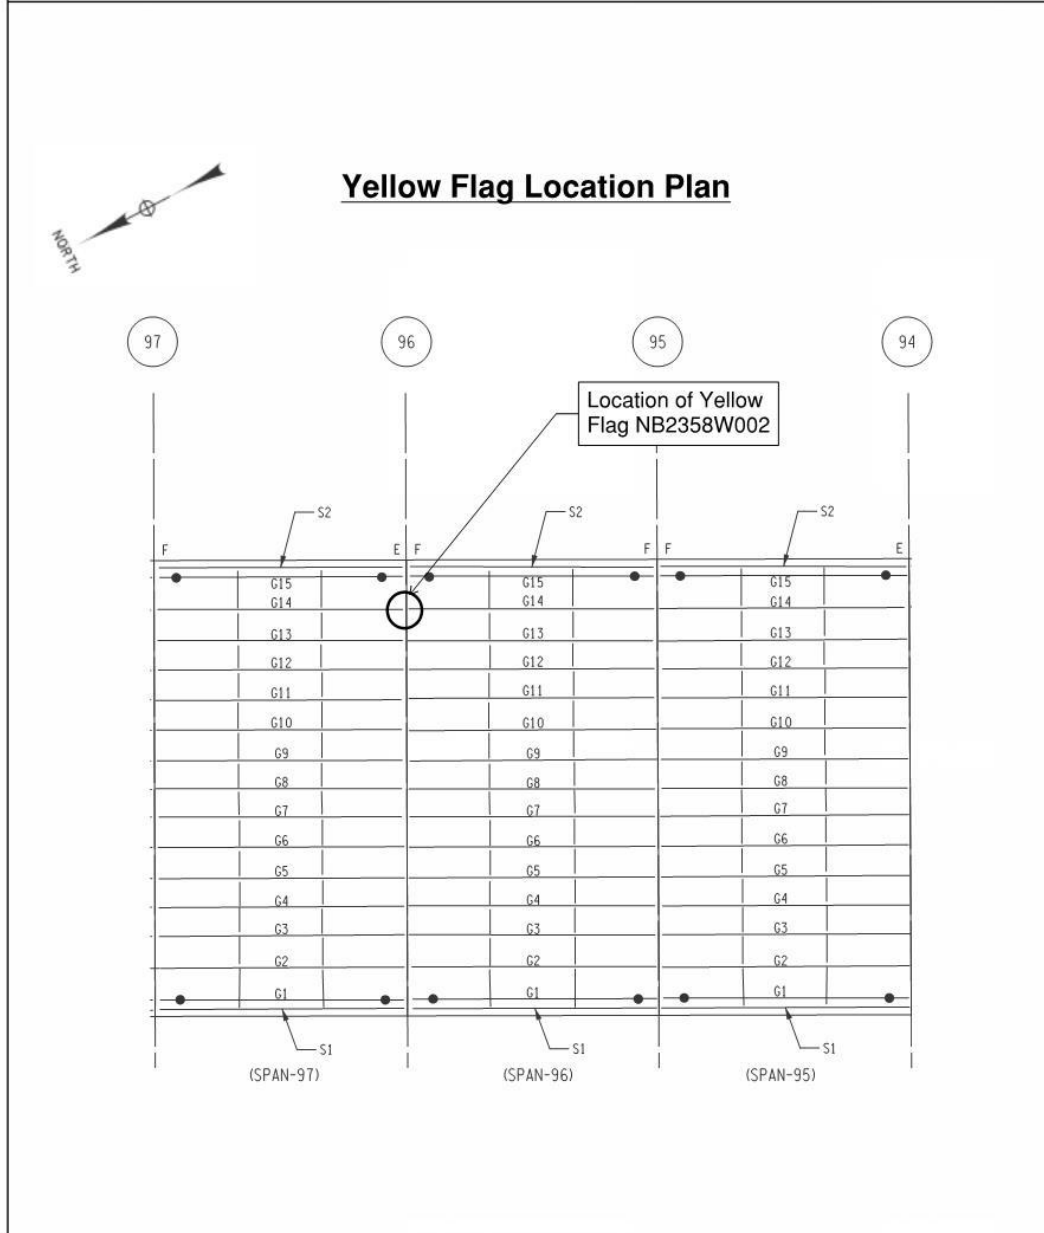
Flag PhotographsPhoto Number: **1**Photo Filename: **23_Flag Location Plan.jpg**Gowanus Expressway
2023 Biennial Inspection - Field SketchBIN: 1065318Team: AA/TSDate: 04/04/2023Span: 96Location: Girder G14 at Pier 96

**Attachment Description: Yellow Flag Location Plan**

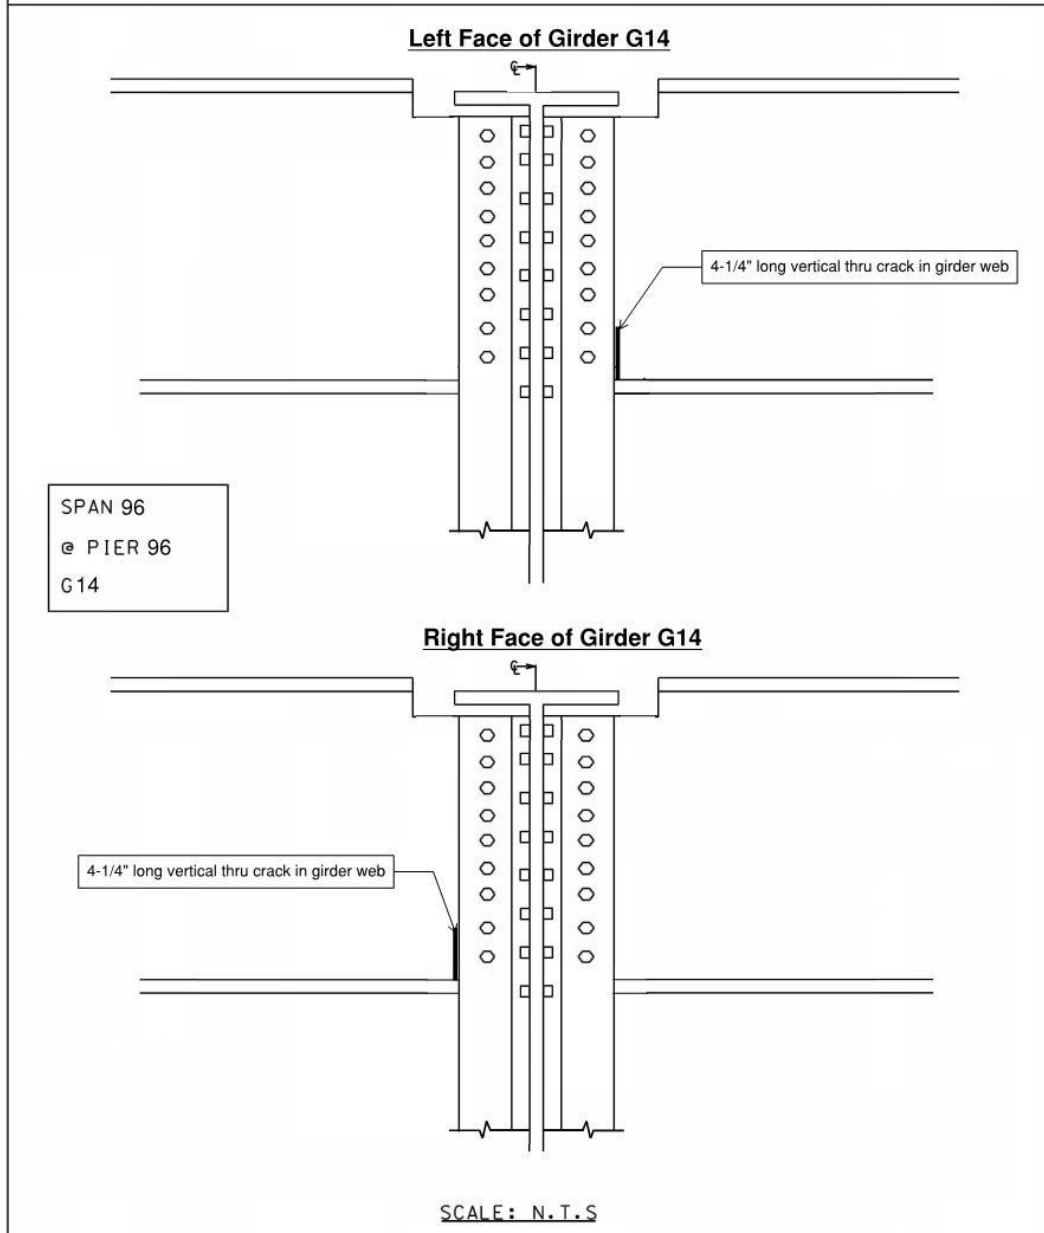
Photo Number: 2

Attachment Description: Yellow Flag Condition Sketch

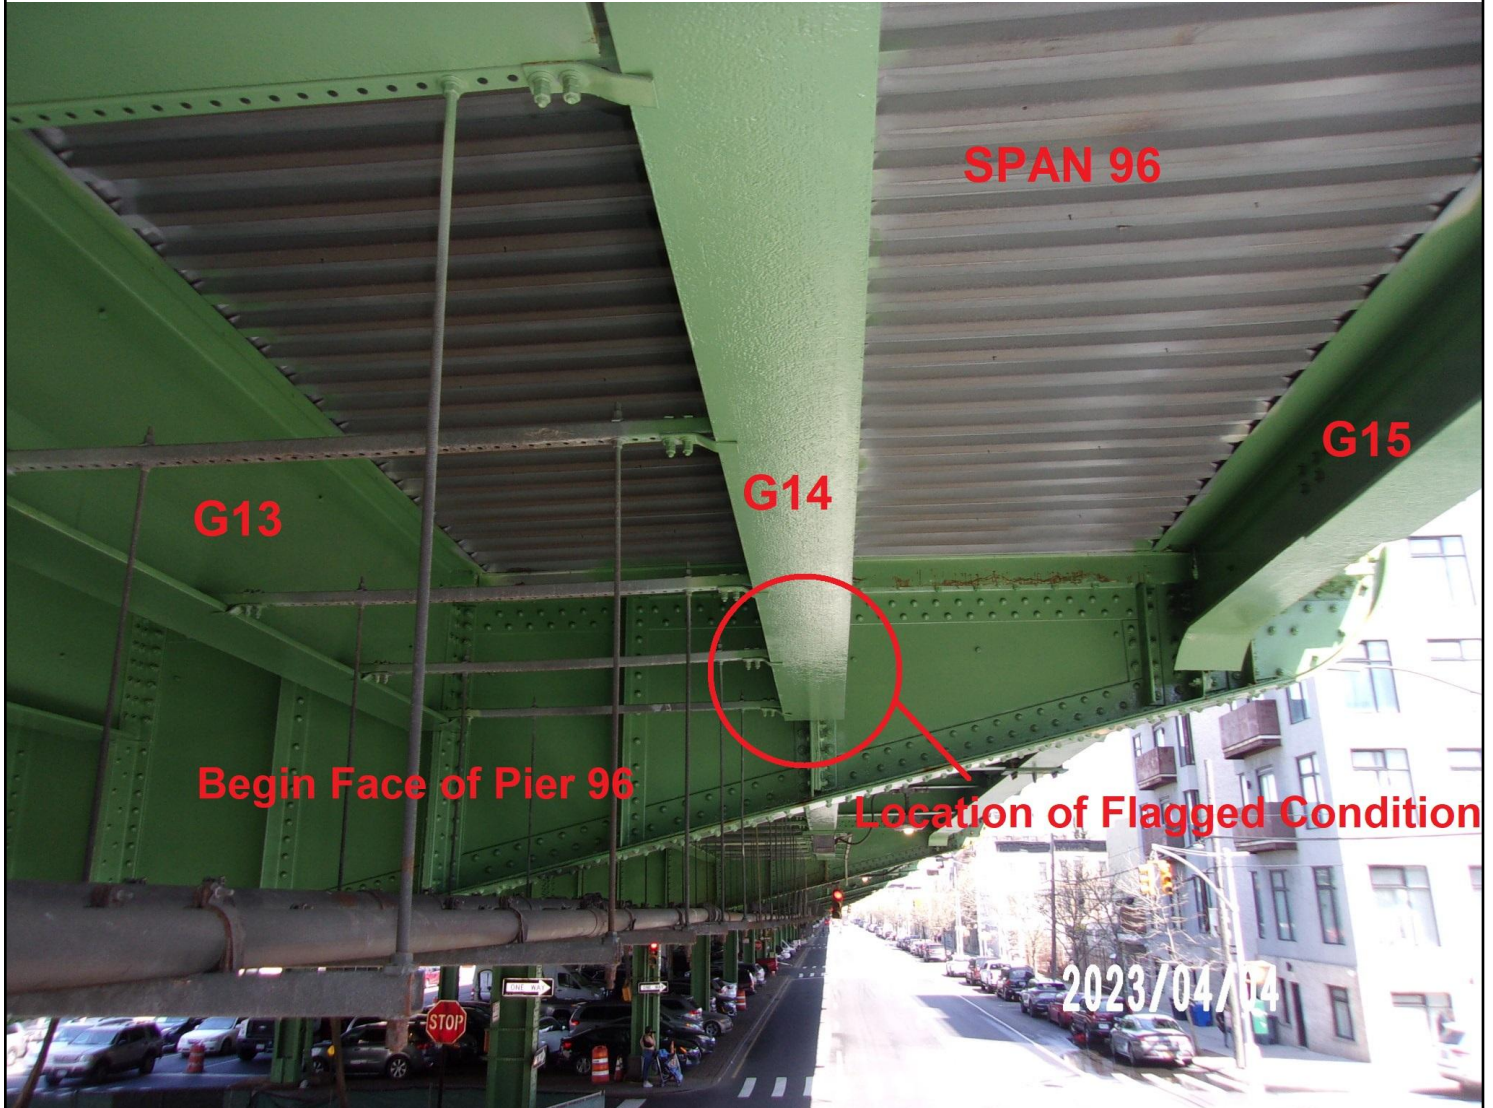
Photo Number: 3

Attachment Description: General view of the flagged condition at Girder G14 in Span 96 at Pier 96. Looking End.

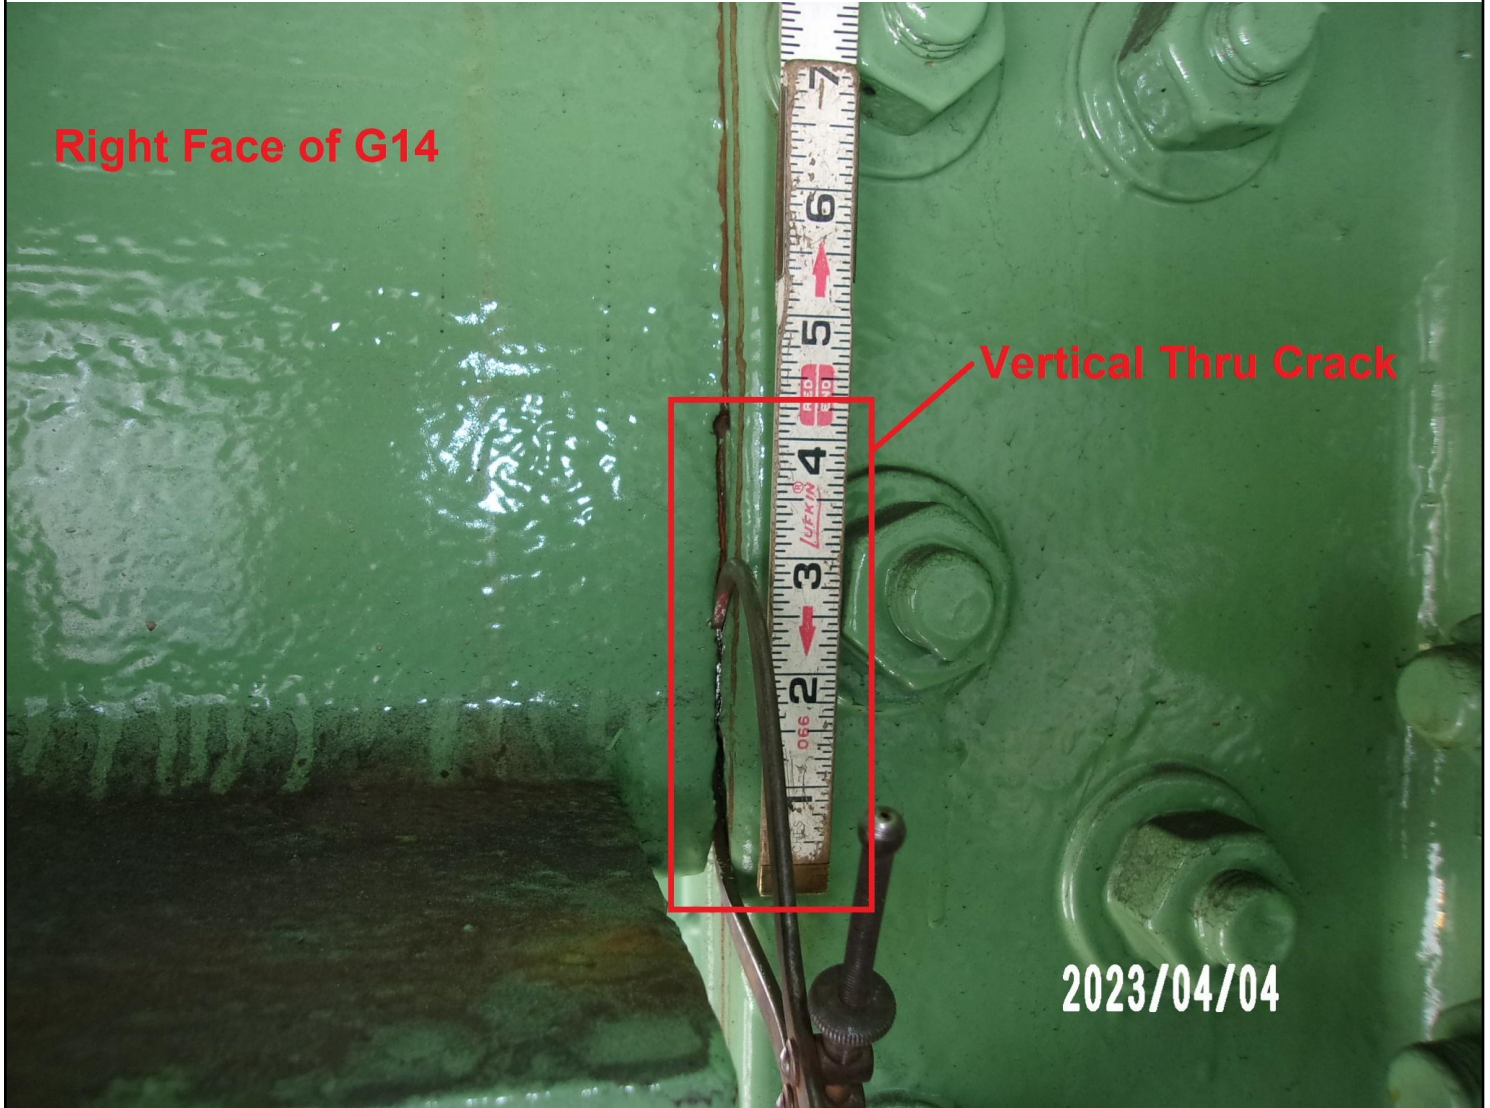
Photo Number: 4

The end of Girder G14 in Span 96 at Pier 96 exhibits 4-1/4" long vertical thru crack starting at the bottom of the girder web adjacent to the connection angle (Photos 4 and 5). The remaining girder web at the pier is in good condition. Also, both connection angles at the girder end are in good condition.

Attachment Description: The right face of Girder G14 in Span 96 at Pier 96. The bottom of the girder web exhibits a 4-1/4" long vertical thru crack adjacent to the connection angle. Looking Left.

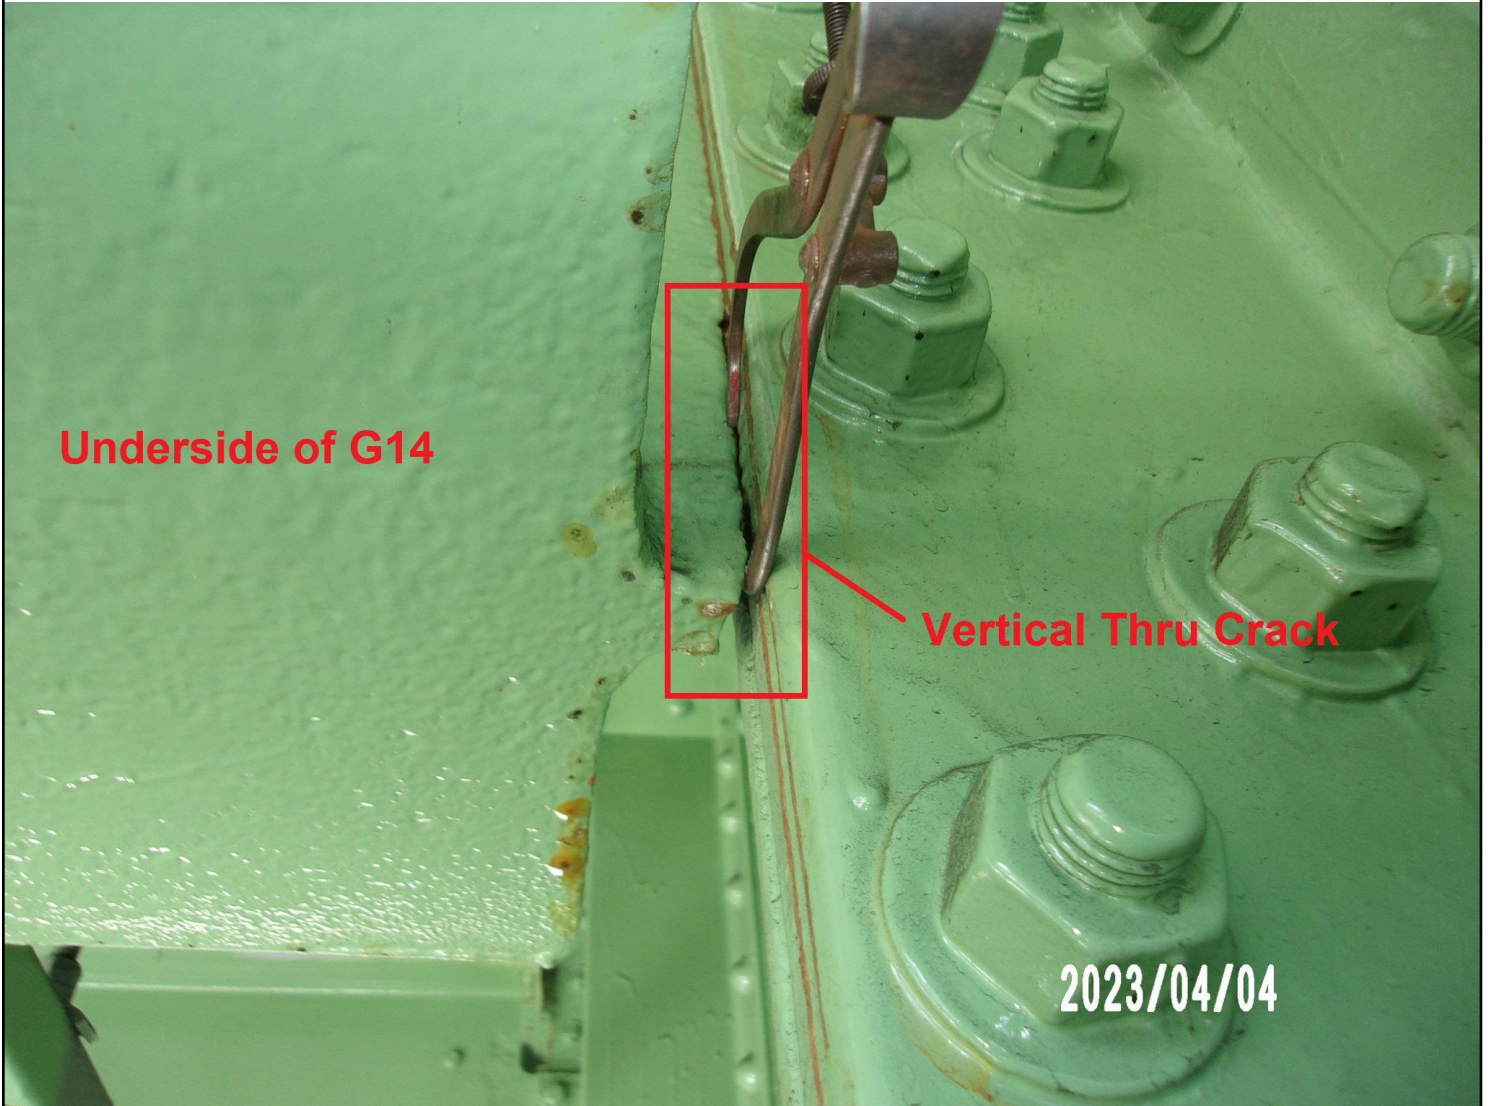
Photo Number: 5

Attachment Description: The underside of Girder G14 in Span 96 at Pier 96. The bottom of the girder web exhibits a 4-1/4" long vertical thru crack adjacent to the connection angle. Looking Left.
